Presidential Emergency Facility Site 2 - "Cannonball"

Atop Cross Mountain, near Mercersburg, PA

Microwave Radio Relay Site

Site 2 - "Cannonball"

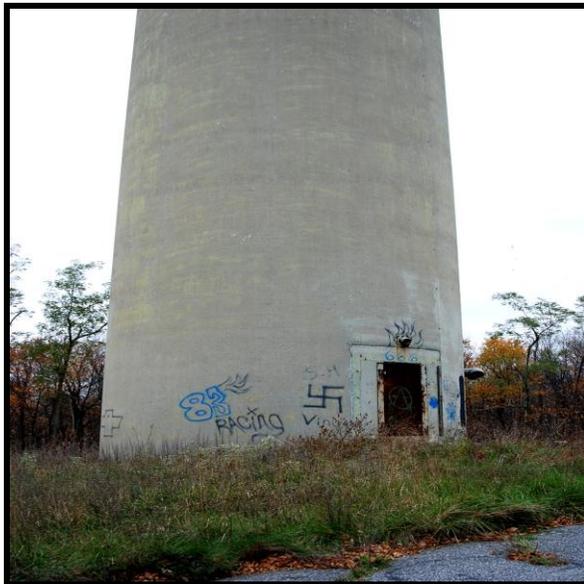
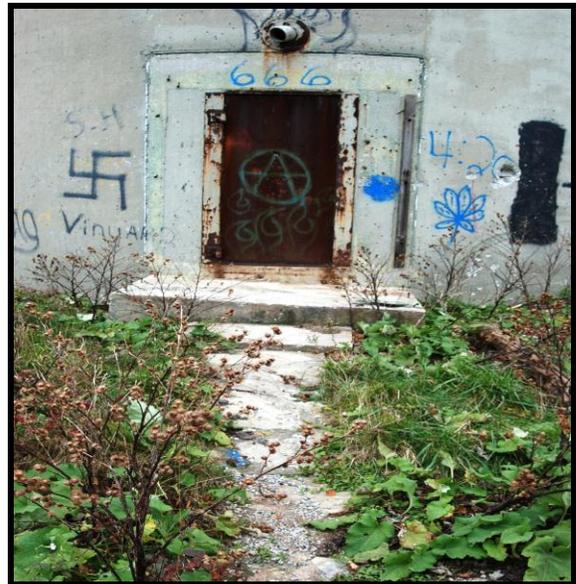
Entranceway into Cannonball Tower (2011)

The tower's sole entrance was secured by a heavy steel blast door - essentially a vault door - which was welded shut when the tower was abandoned in 1977. Despite that precaution, the door has been stolen. Only the frame and attached hinges remain.

The circular opening above the doorway is the exhaust for the tower's ventilation system.

The rectangular outline surrounding the doorway and the vertical pieces of lumber attached to the wall with the bolts protruding from the wall and stoop suggest that the tower had an enclosed porch.

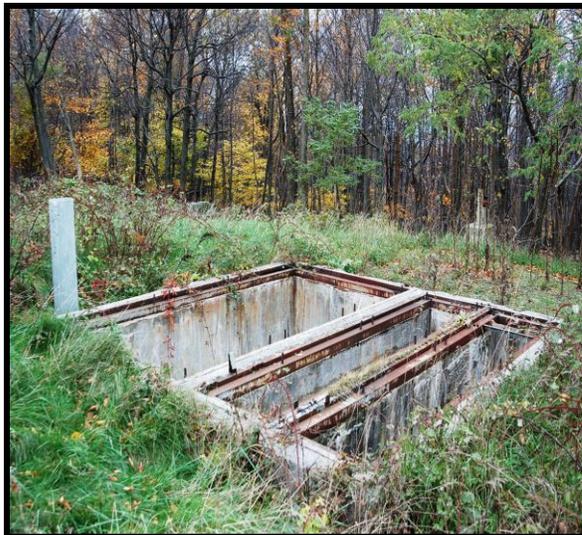
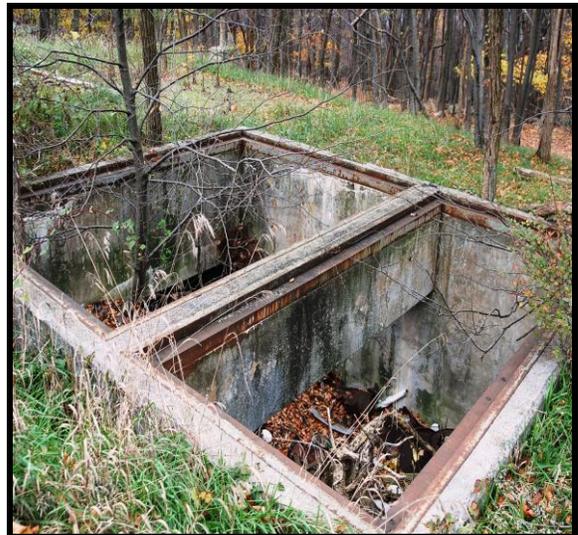
The emergency generator and power transformers were located in this pit.

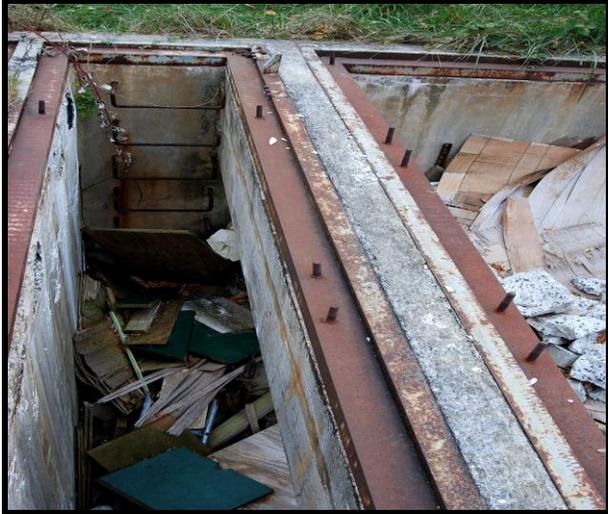
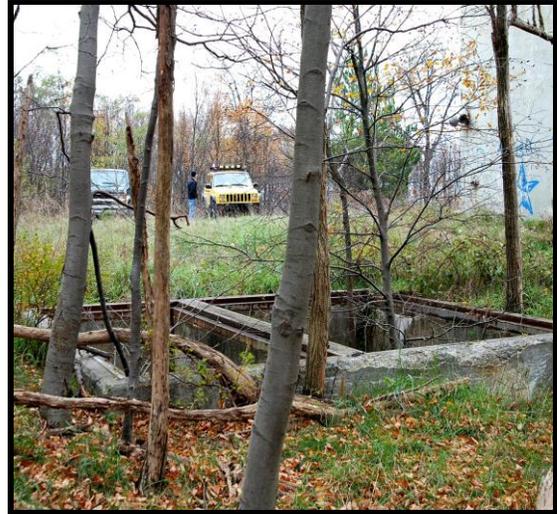
The generator pit filled with debris

c. Pictures 15 through 18 are of the old transformer and generator vaults. Pictures 17 and 18 shows that a lot of debris has been accumulated in these vaults over the years. This area should be investigated to make sure that no PCB's were spilled when the potentially PCB filled transformers were removed. An open pit like this is a serious safety hazard.

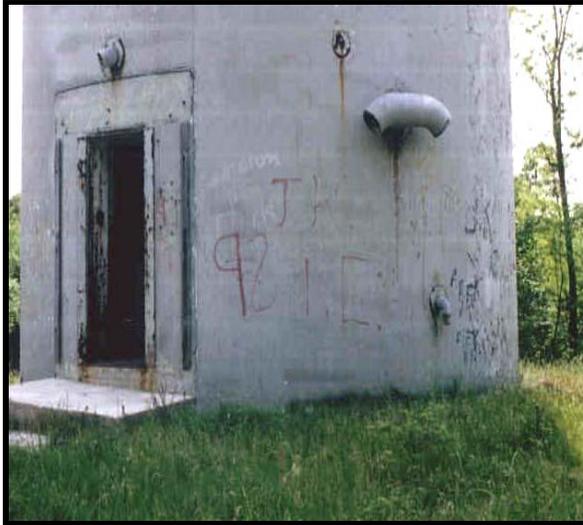
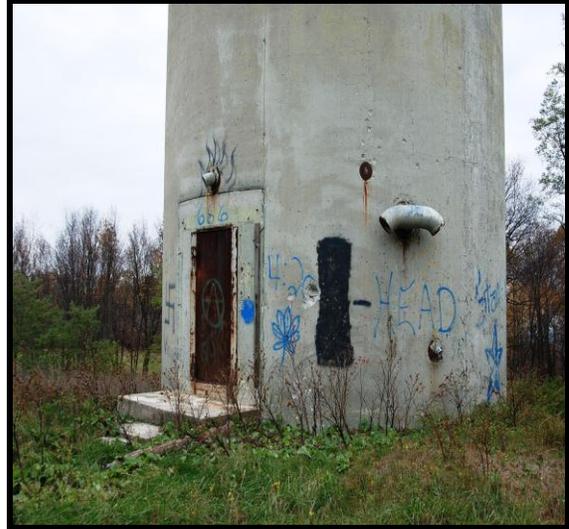
Sole entrance/exit (blast door is missing) in 1999, steel plate covers entrance in 2011

The tower was entered by walking up one or two concrete steps, through an entranceway that based on the door frame, once had a vault-like door. The first chamber entered was the decontamination room, where you'd remove contaminated clothing & shower, then be let into another small room (walled with pink tile, ROBERTSON 39 MADE IN USA cast on the back of the tiles) to put on clean clothes before finally entering main ground floor area. There was a 1'x 1' window which would allow someone inside the second room to observe a person entering the bunker and decontaminating before they were allowed into the second small room.

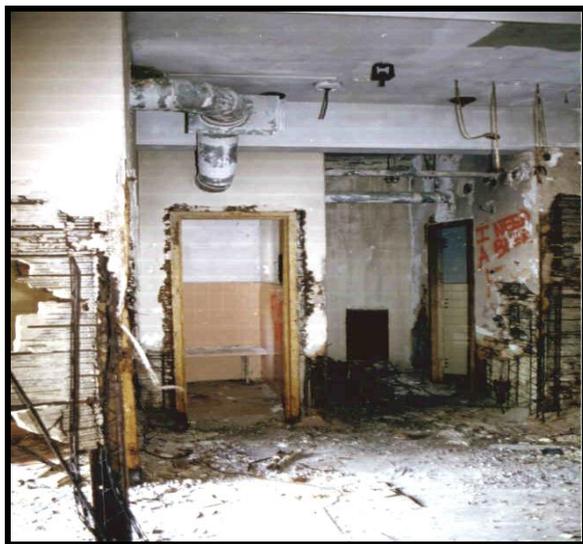
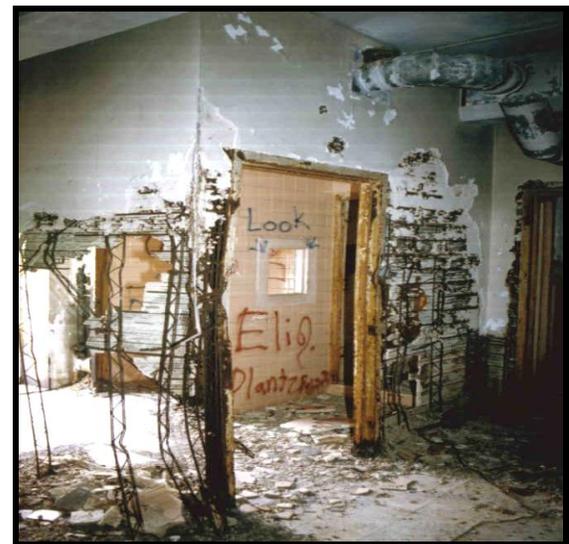
First floor entrance, Decon room with pass through and changing area

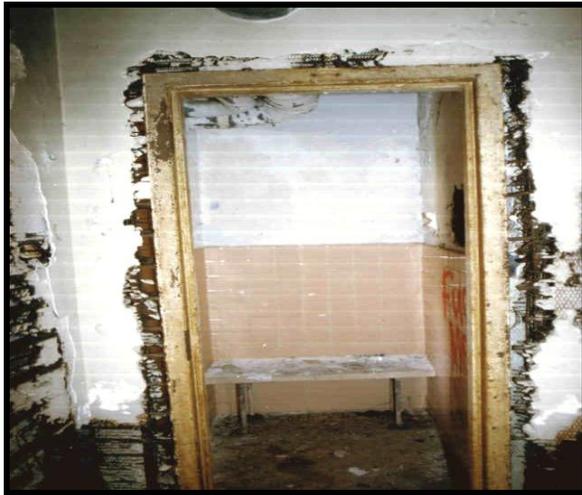
Decontamination changing station

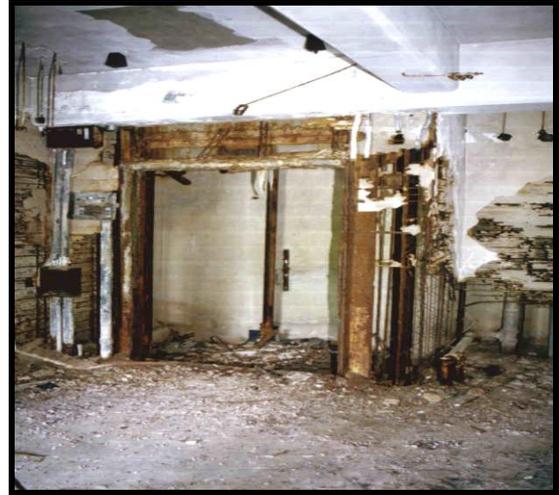
(Otis) elevator shaft, Note all of the misc. water pipes, power, and air ducts.

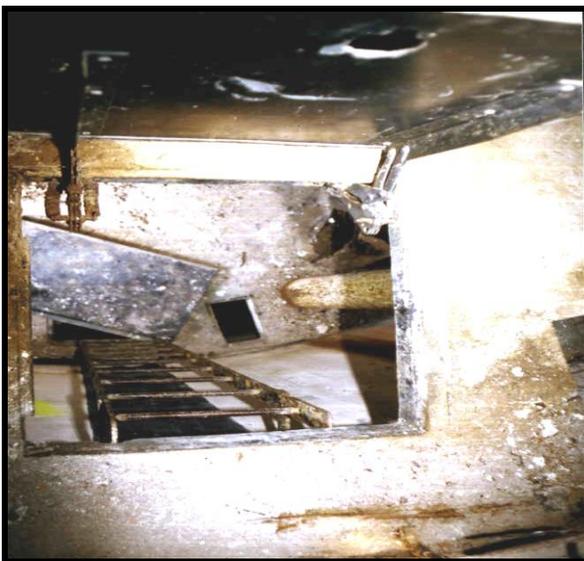
Ladder way on second floor

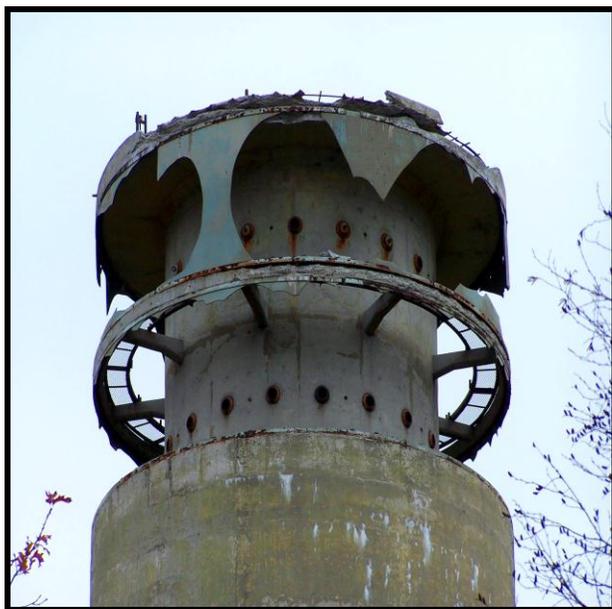
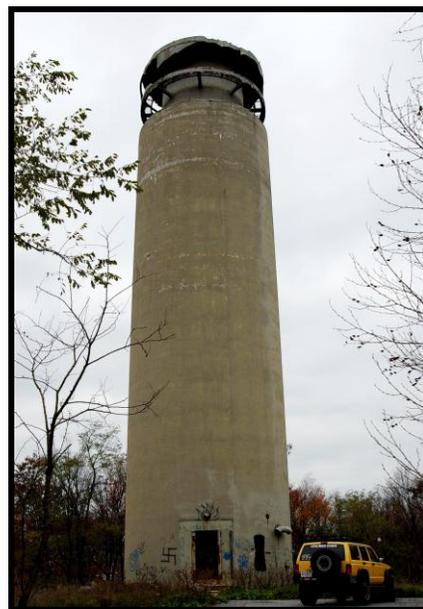
The top two floors were the antenna decks originally enclosed by Plexiglas

The top tiers were home to microwave antennas, protected behind a Plexiglas cover (busted but shreds are still in place, and fall to the ground occasionally!) You can see the doorway on the upper left, which allowed personnel to adjust the antennas. It was a blast door, The flat open land clearing to the right was a helicopter landing zone, a large log periodic antenna was in-between the tower and the helicopter landing pad.

Plexiglas protected the microwave dishes on the top level from weather elements, and it was coated on the inside by a special, RF-transparent paint manufactured by Sherwin-Williams. The paint was purely an operational security measure -- it prevented anyone in the vicinity of the tower from seeing where the microwave antennas pointed and having clues as to where other classified sites linked by microwave with Cannonball were.

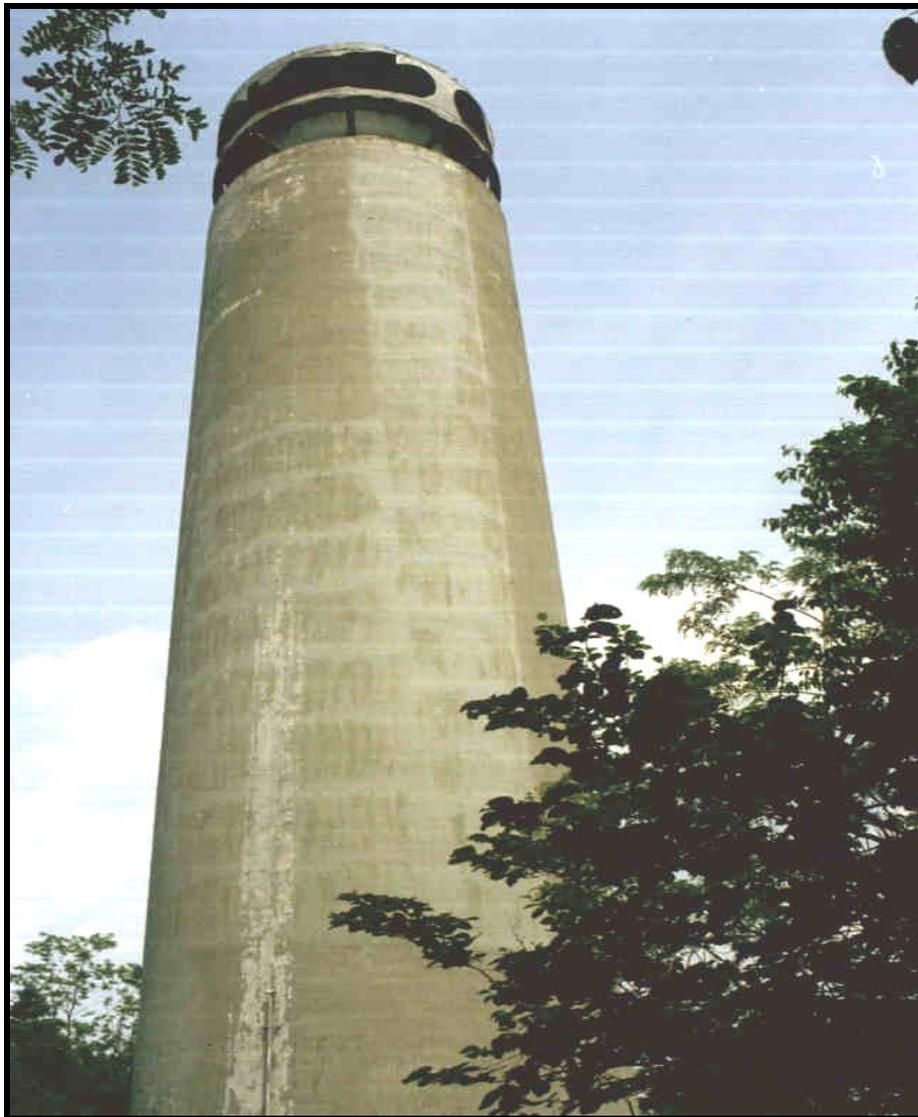
103' tower, "The broken Plexiglas layer at the top is quite visible. A sharp piece falling from the top could kill!"

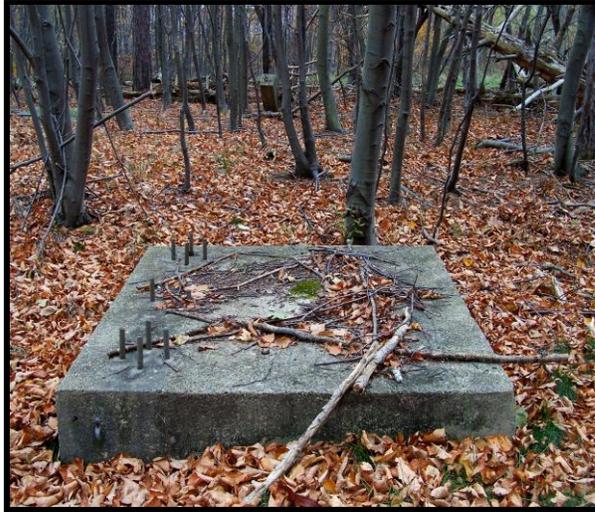
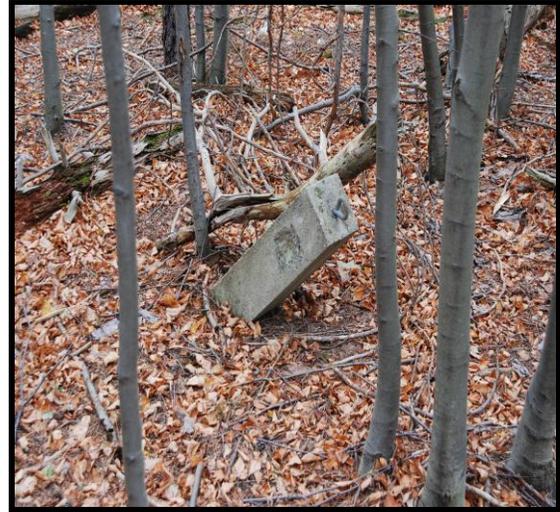
We had quite a few construction projects take place during the 1968 thru 1970 one was the construction of some Log Periodic HF antennas. The 80 ft. tower was equipped with a winch which allowed us to raise and lower the tower and antenna for maintenance. We spent a couple of months building the LP at Cannonball and adding a second three element beam to the rear of the garage. The plan was to have Cannonball become the remote transmitter site for Cactus. We also installed a four channel Multi-coupler on the fifth floor. I am not sure of the exact time frame but Cactus was also constructing a similar LP antenna I think it was going up behind the barracks and Mess Hall. I think the plan was to add additional transmitters because I was sent to the Naval Station at Norfolk VA., in May of 1969 for training on the AN/URT 23 and the AN/URR 1051 (these units would become part of the CCT packages); however we would never receive any additional systems. Unfortunately we would never have the opportunity to really use the system as a remote transmitter because in the fall of 1969 during a severe storm the LP antenna was severely damaged and was never repaired.

Base of the LP Antenna and Anchor for one of the Guy Wires

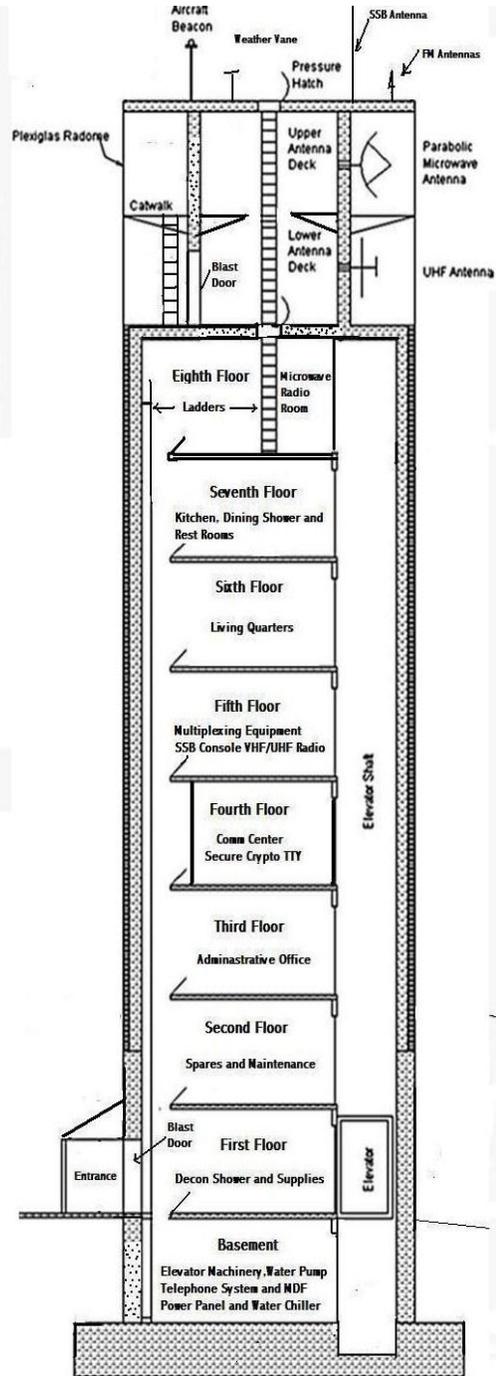
Microwave Radio Relay Site Cross Section View of Tower

Antenna Deck: There were two levels that needed to be accessed. The lower external area was accessed through a single blast door a ladder then allowed ascent to a catwalk which circled the tower. Internal access to the upper antenna area and the roof was accomplished by climbing a ladder first to a catwalk circling the interior wall then a ladder to the pressure hatch in the roof.

Eighth Floor: Eight systems of microwave equipment were installed on this floor. Three systems went to Cactus, three systems went to Cowpuncher and two systems went to Corkscrew. All maintenance spares for the radio equipment was stored on this floor. The facilities main power panel, for the emergency generator, air conditioning and lighting systems. All of the equipment in this room was mounted on a shock proof floor which was suspended from the ceiling by heavy steel springs.

First Floor and Entrance: The entrance was a 12 inch thick steel blast door that opened by using a hydraulic system. The first floor also had a radiation de-contamination station which consisted of a dressing room and a shower. There were supplies such as gas masks and other equipment necessary to detect or combat any Chemical, Biological or Nuclear contaminants. There was also a hot water tank located on this floor.

Basement: All of the facilities mechanical equipment was located here. The HVAC power panel, the air purification system, the elevator control panel, the water system pump and water chiller for the air handling units located on each floor. All of the telephone cables from external sources including a 100 pr. underground cable from the AT&T site at Hearthstone Mt. entered the building and terminated on the main distribution frame (MDF). The sites telephone key system was also located in the basement.
